Diagnostic tips in practice: RATTLING NOISE

CAR MAKES A RATTLING NOISE, THE ENGINE WARNING LIGHT ILLUMINATES

Car: VW Polo V 1.2 TSI (CBZB) 2009-14 (Type-ID 102001075)

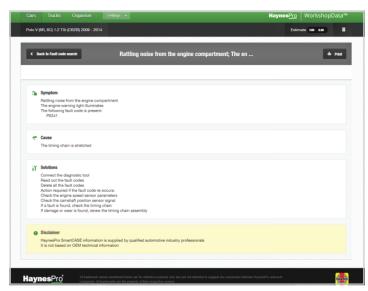
WorkshopData's genius lies in its additional searches for SMART data linked to these fault codes. In this case WorkshopData reveals a SmartCASE linked to fault code P0341; its description relates to our Polo's symptoms.

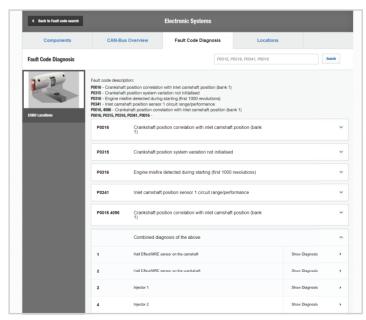
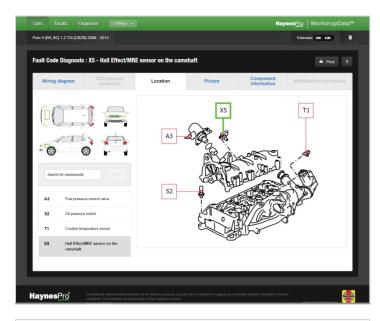
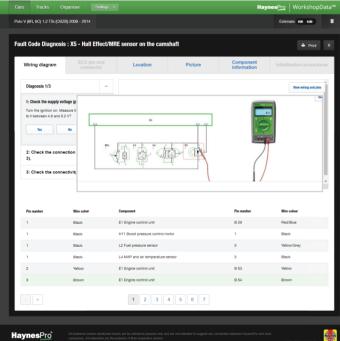
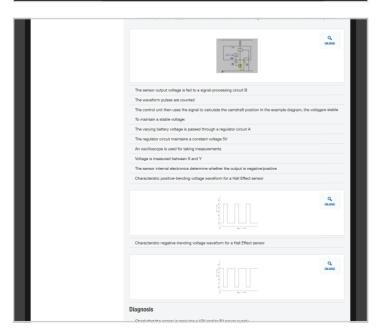
Step 2. Using HaynesPro's unique VESA feature, the technician then follows the suggested step-by-step diagnostic route to confirm that the wiring for both sensors is correct. The scope patterns of both sensors also appear to be correct. With closer inspection and while revving the engine, fluctuations in the timing between crankshaft and camshaft are noticed; a typical symptom of a worn timing chain.

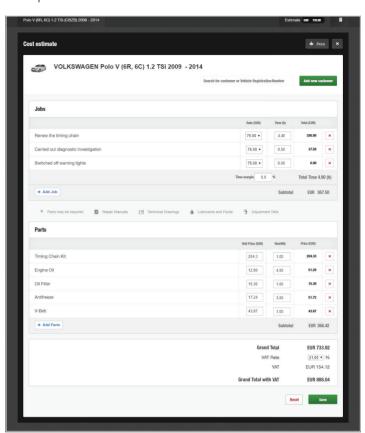
Step 3. With both the crankshaft and camshaft sensors working correctly and the timing chain verified as the cause of the problem, the time has come to notify the owner. WorkshopData is now used to create a cost estimate. Using the timing chain repair manual, the technician identifies the parts and time required for the repair.
